CORROSION TESTING OF ADVANCED COATINGS IN ACCORDANCE WITH HARD CHROME ALTERNATIVES TEAM ACTUATOR JOINT TEST PROTOCOL

Hard Chrome Alternatives Team Meeting San Diego, CA – January 24, 2006

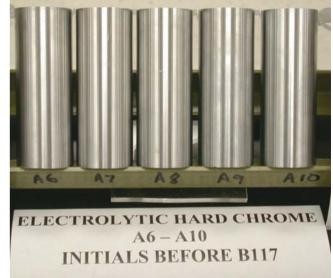
1045 alloy cold rolled steel shafts, 38 mm (1.5") in diameter, 101.5 mm (4") lengths

- Bare (uncoated) shafts
- EHC, 2 mils, per SAE AMS-QQ-C-320, "Chromium Plating (Electrodeposited)"

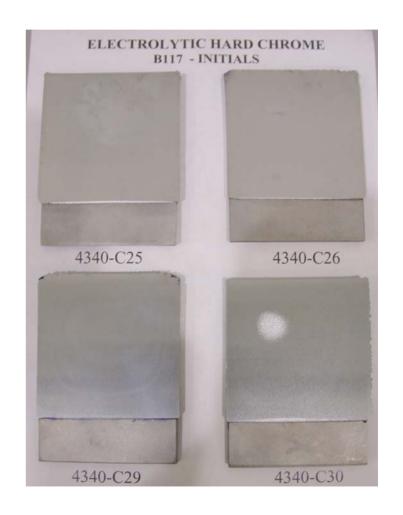
- HCAT Panels
 - EHC and TS coated panels
 - Three substrates
 - 4340 steel alloy
 - Precipitation hardened (PH)15-5 steel
 - Titanium 6-4 alloy
 - Three coatings
 - EHC
 - Thermal sprayed tungsten carbide cobalt chrome
 - Thermal sprayed T400

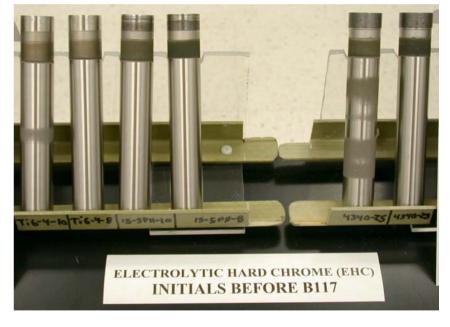
- HCAT Shafts
 - EHC and TS coated specimens
 - Three substrates
 - 4340 steel alloy
 - PH 15-5 steel
 - Titanium 6-4 alloy
 - Four coatings
 - EHC
 - Thermal sprayed tungsten carbide cobalt chrome
 - Thermal sprayed chromium carbide
 - Thermal sprayed T400

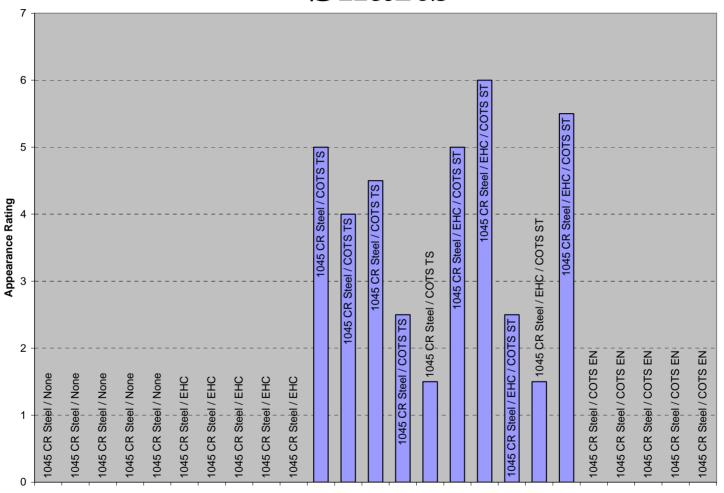
B117 – Appearance Rating After 1000 Hours

- Uncoated and EHC-plated shafts exhibited high corrosion rates, as expected
- COTS TS provided improved protection when compared to uncoated and EHC
- COTS ST provided improved performance to EHC
- COTS EN exhibited significant corrosion
- Corrosion performance enhancement of TS and ST specimens over EHC is evident

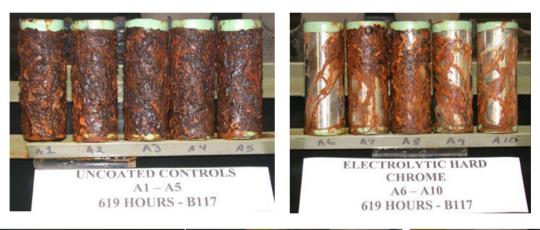
• TDPMD specimens after 619 hours of B117

COTS ST

COTS EN

COTS TS

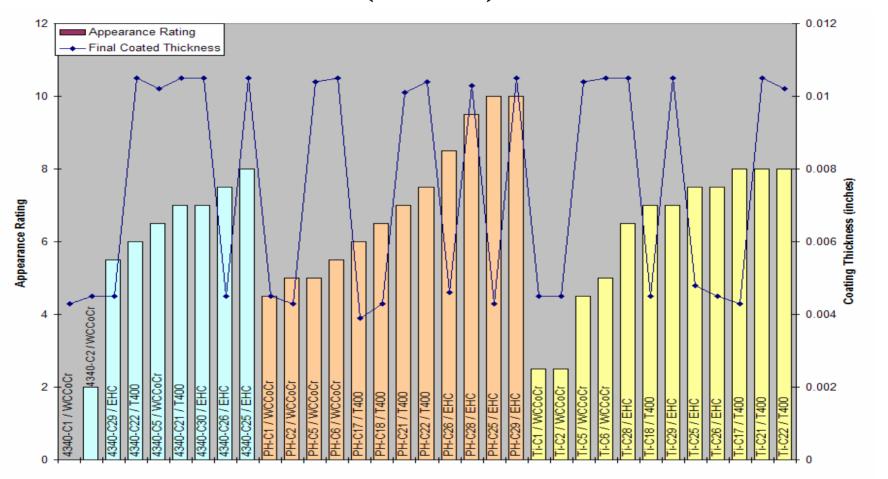
Coating Thickness vs. Appearance Rating After 1000 Hours, by Substrate

- Results very different than those of TDPMD specimens
 - Performed better than all TDPMD specimens
 - Could be related to process, but probably influence of coating thickness
- Some substrate influence
- EHC best performer on all three substrates
- T400 comparable to EHC on all three substrates
- Tungsten carbide cobalt slightly less protection than EHC
 - Inconsistent with past HCAT work

- Appearance rating related to coating thickness
- Appearance rating vs. Ra results inconclusive, but apparently independent of appearance rating
 - NOTE: Ra = average surface roughness,

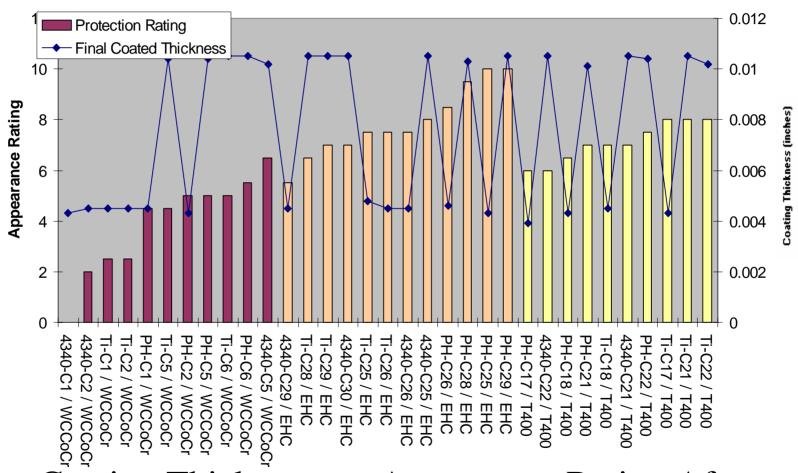
Coating Thickness vs. Appearance Rating After 1000 Hours, by Coating

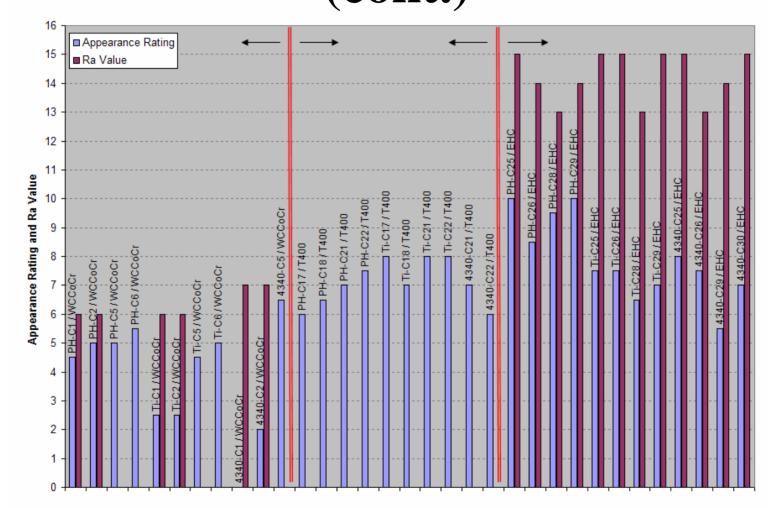
Surface Roughness (Ra) vs. Appearance Rating after 1000 Hours, by Coating

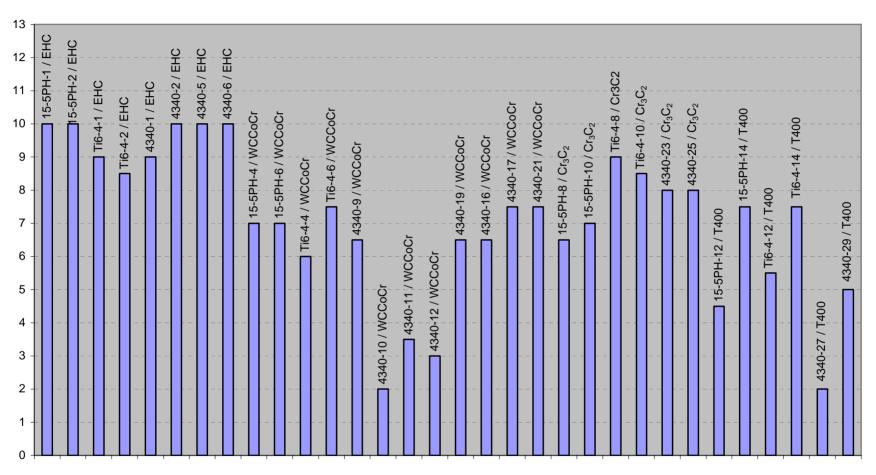
B117 – Appearance Rating After 1000 Hours

- Results very different than those of TDPMD specimens
 - Performed better than all TDPMD specimens
 - Could be related to process, but probably influenced by coating thickness
- Some substrate influence
- EHC best performer on all three substrates
- Chrome carbide, tungsten carbide provided similar protection (but slightly less than EHC)
- T400 provided less protection
 - Consistent with past HCAT work

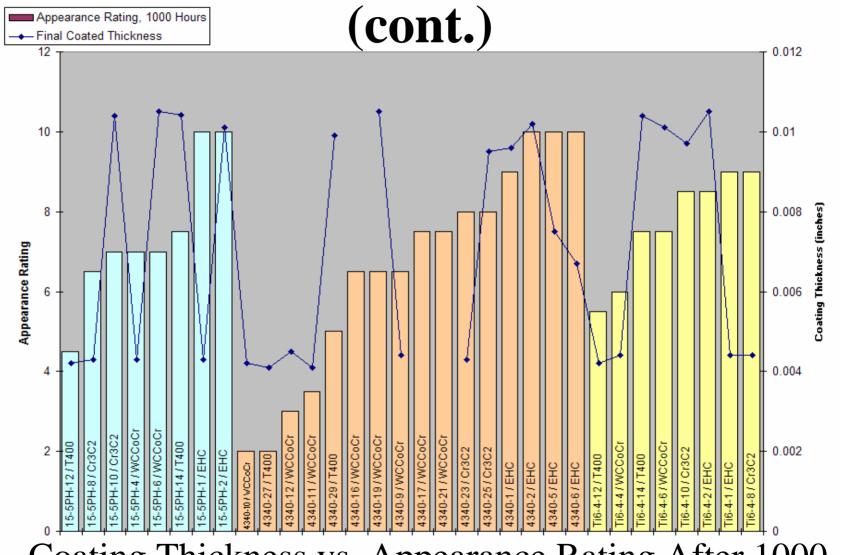
Coating Thickness vs. Appearance Rating After 1000 Hours, by Substrate

- Appearance rating related to coating thickness
- Appearance rating vs. Ra results inconclusive, but apparently independent of appearance rating

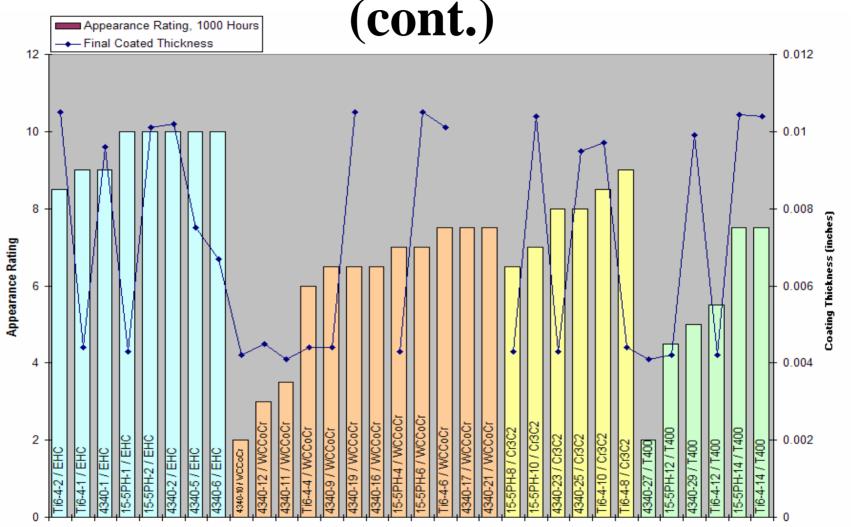
Coating Thickness vs. Appearance Rating After 1000 Hours, by Coating

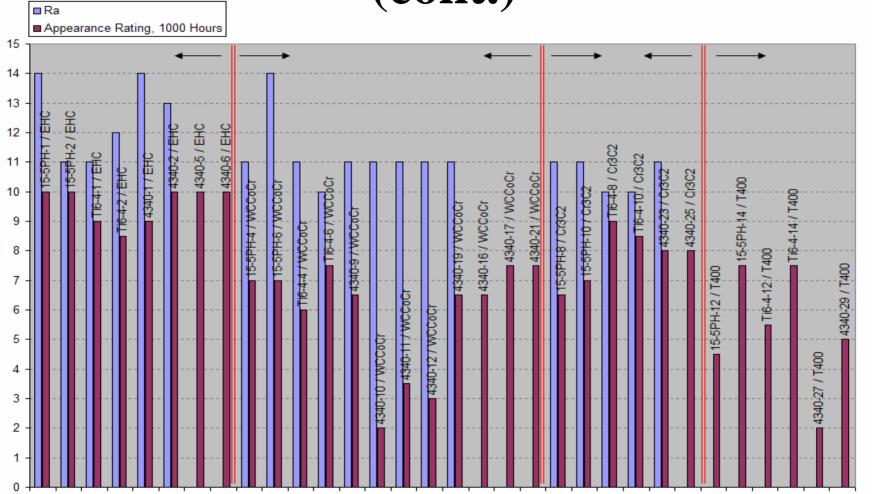
Ra vs. Appearance Rating after 1000 Hours, by Coating

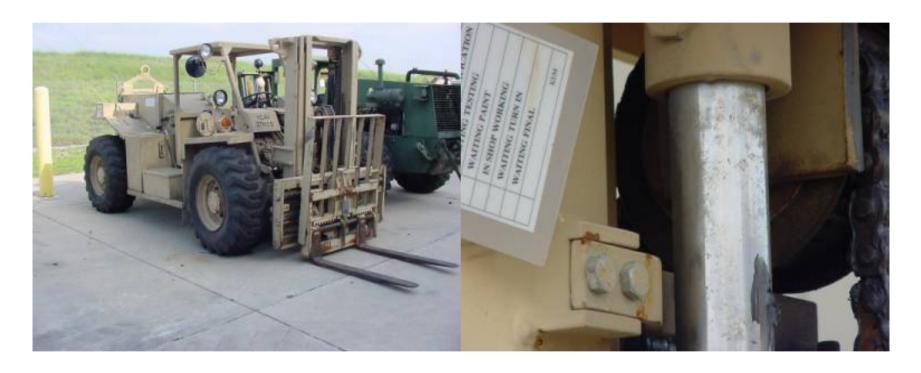
• Corrosion on Actuator of M4K Tactical Forklift

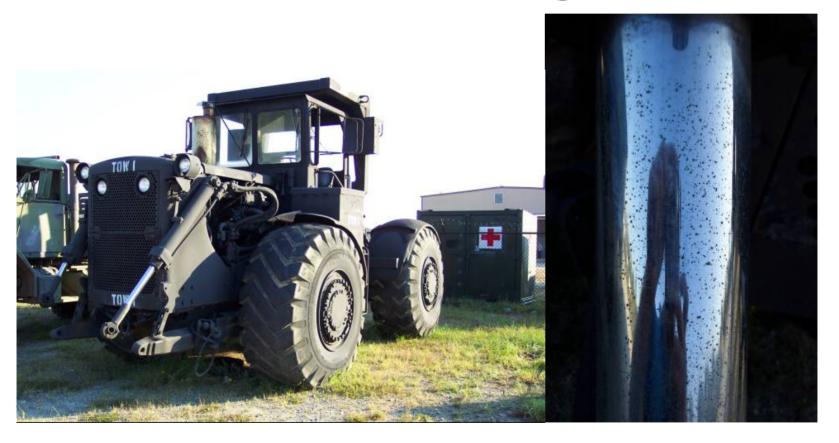
Pitting Corrosion on Actuator on Wheeled Tractor

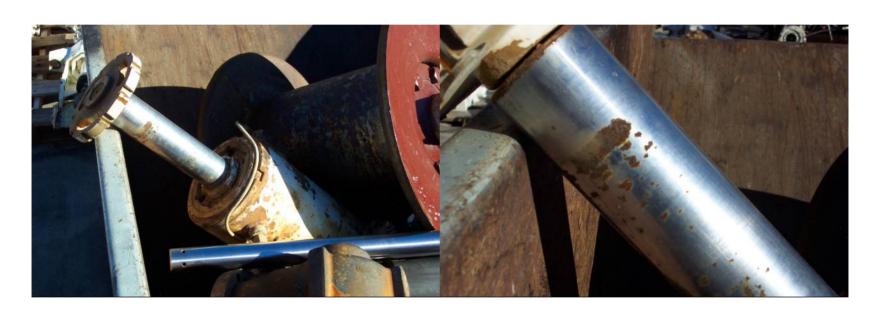
Corrosion on Hydraulic Actuator

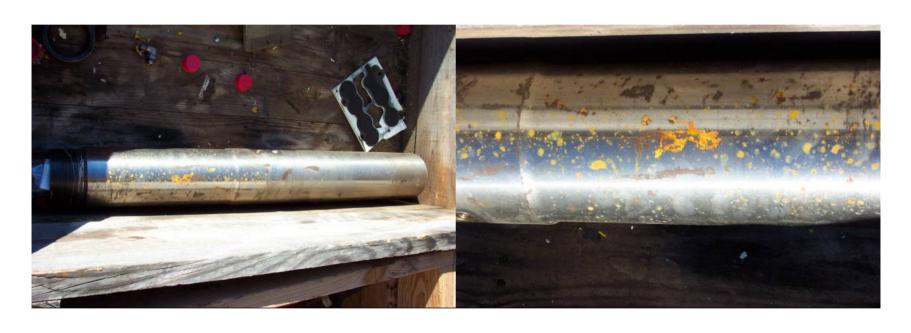
Corrosion on Hydraulic Actuator
